## From Microscopic Degradation to Grid Resilience: A Comprehensive Analysis of Surface Tracking Mechanisms and Predictive Mitigation in Polymeric Insulators

### Abstract

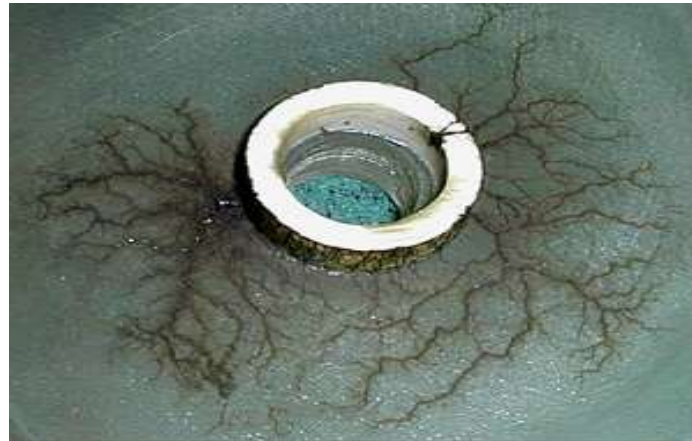
Figure 7: Treeing in underground cable insulators

within the dielectric, where field enhancement causes progressive electrical breakdown of the material. These trees grow as branched, dark carbonized channels, often visible to the naked eye in advanced stages. The development of electrical trees is closely tied to rapid voltage transients, such as those occurring during switching operations or lightning impulses, which induce steep field gradients across the insulation. As the tree structure advances, it eventually bridges the electrodes, forming a conductive path that precipitates full insulation failure [4,31]. Electrical treeing can originate from water tree precursors. Once the tree-like microcavities of a water tree are subjected to sufficient electrical stress, they may transition into electrical trees, leading to rapid deterioration. The carbonized tracks left behind during this process are highly conductive and permanently compromise the insulation's dielectric properties [2]. The figure 7. (adapted from [Wikipedia – Electrical Treeing] ([https://en.wikipedia.org/wiki/Electrical\\_treeing](https://en.wikipedia.org/wiki/Electrical_treeing))) illustrates an advanced stage in the evolution of electrical treeing. At this stage, the tree channels have undergone extensive carbonization, as indicated by their darkened morphology. The formation of these carbonized, electrically conductive pathways results in a permanent breakdown of the dielectric, rendering the restoration of its insulating properties unattainable.
